Debris/Ice/TPS Assessment And Photographic Analysis For Shuttle Mission STS-43

DEBRIS/ICE/TPS ASSESSMENT
AND
PHOTOGRAPHIC ANALYSIS
OF
SHUTTLE MISSION STS-43

August 2, 1991

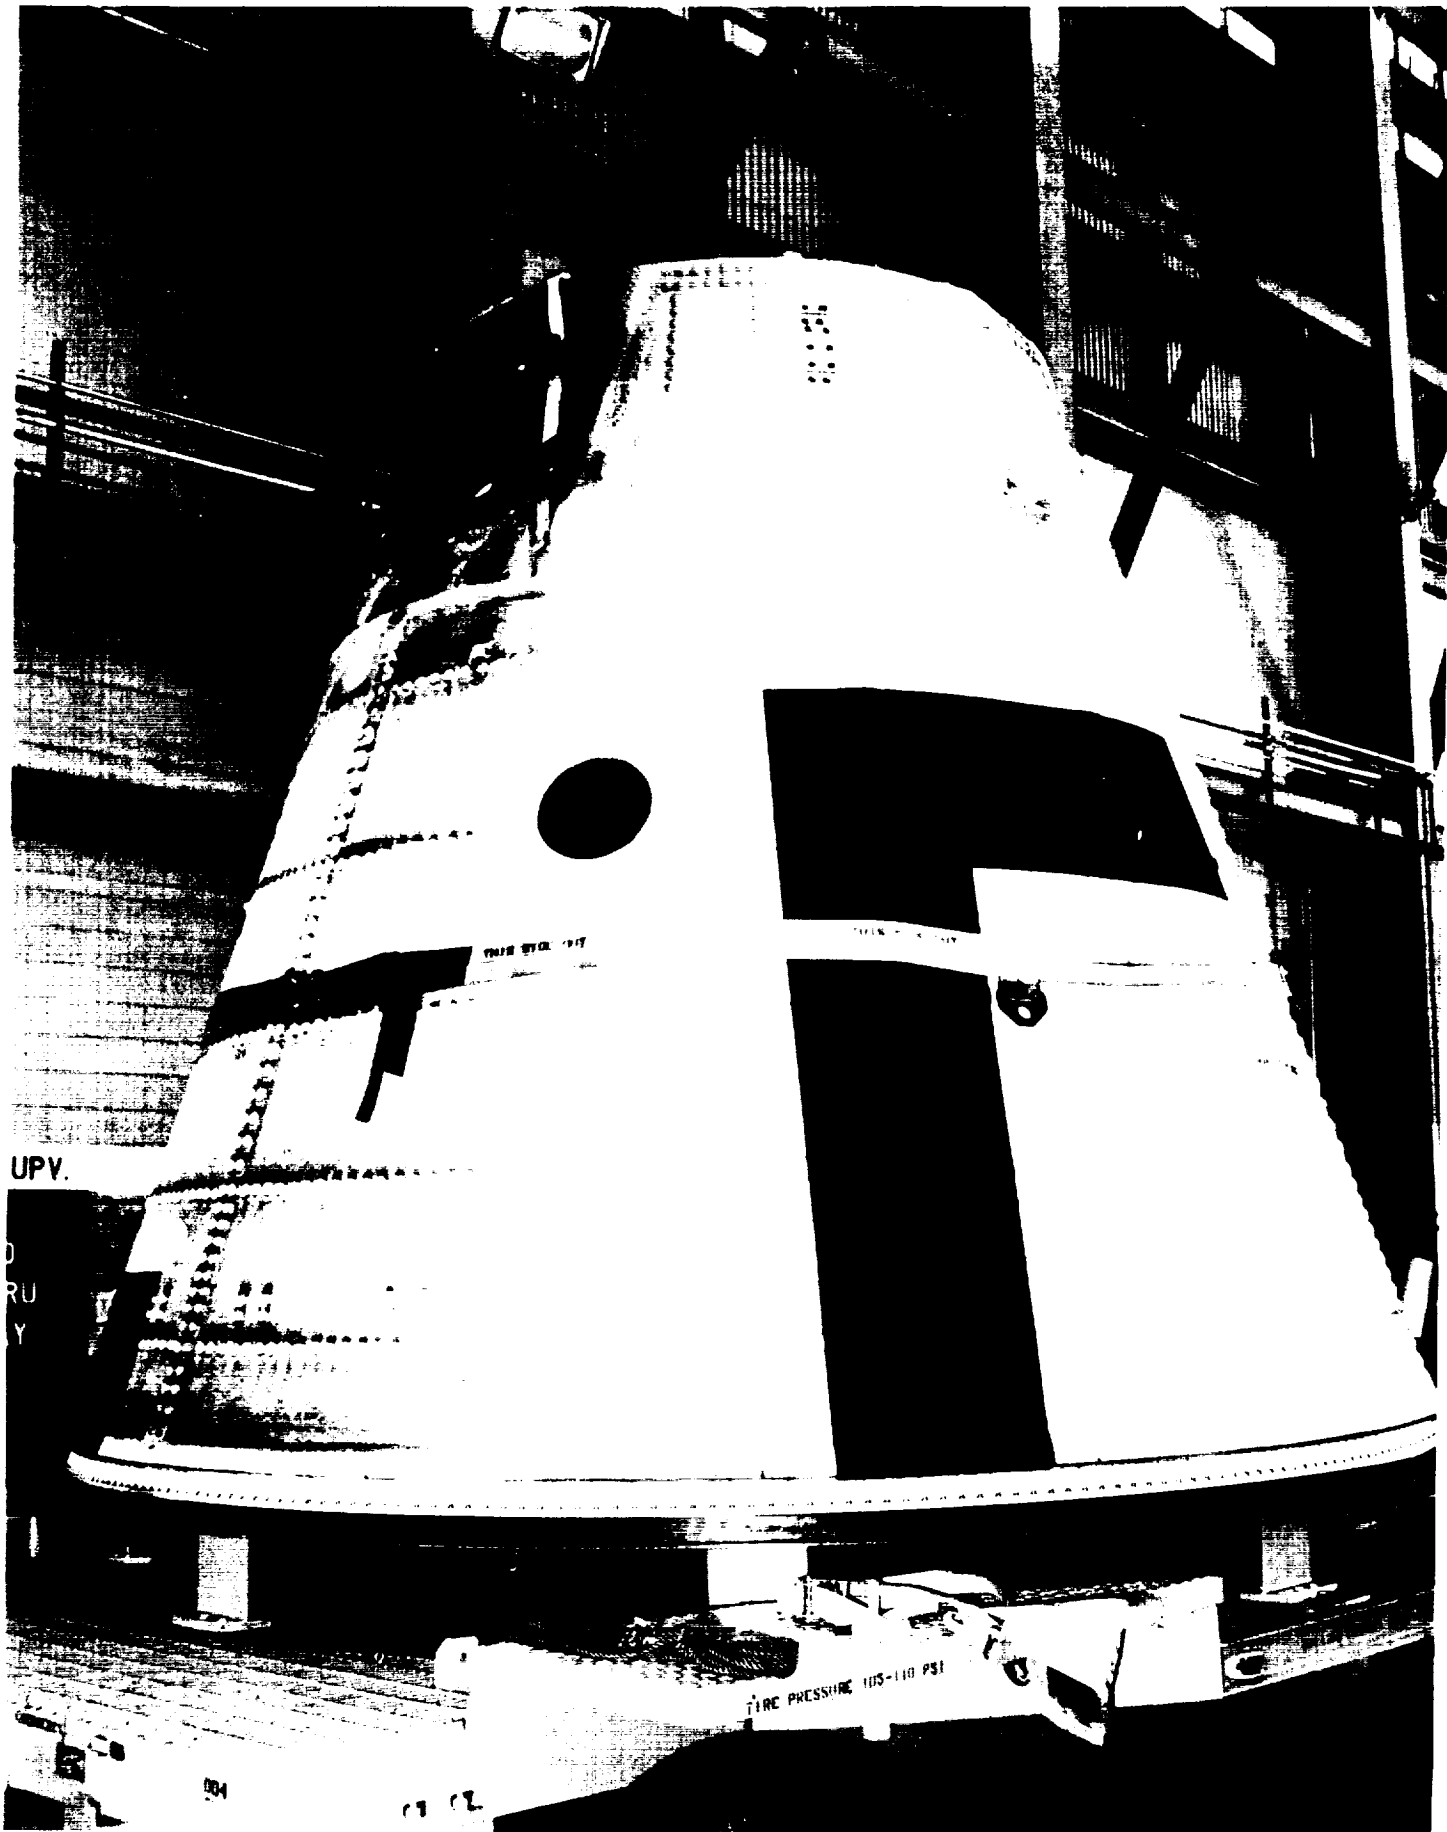
The RH frustum was missing no TPS but had 46 MSA-2 debonds over fasteners.

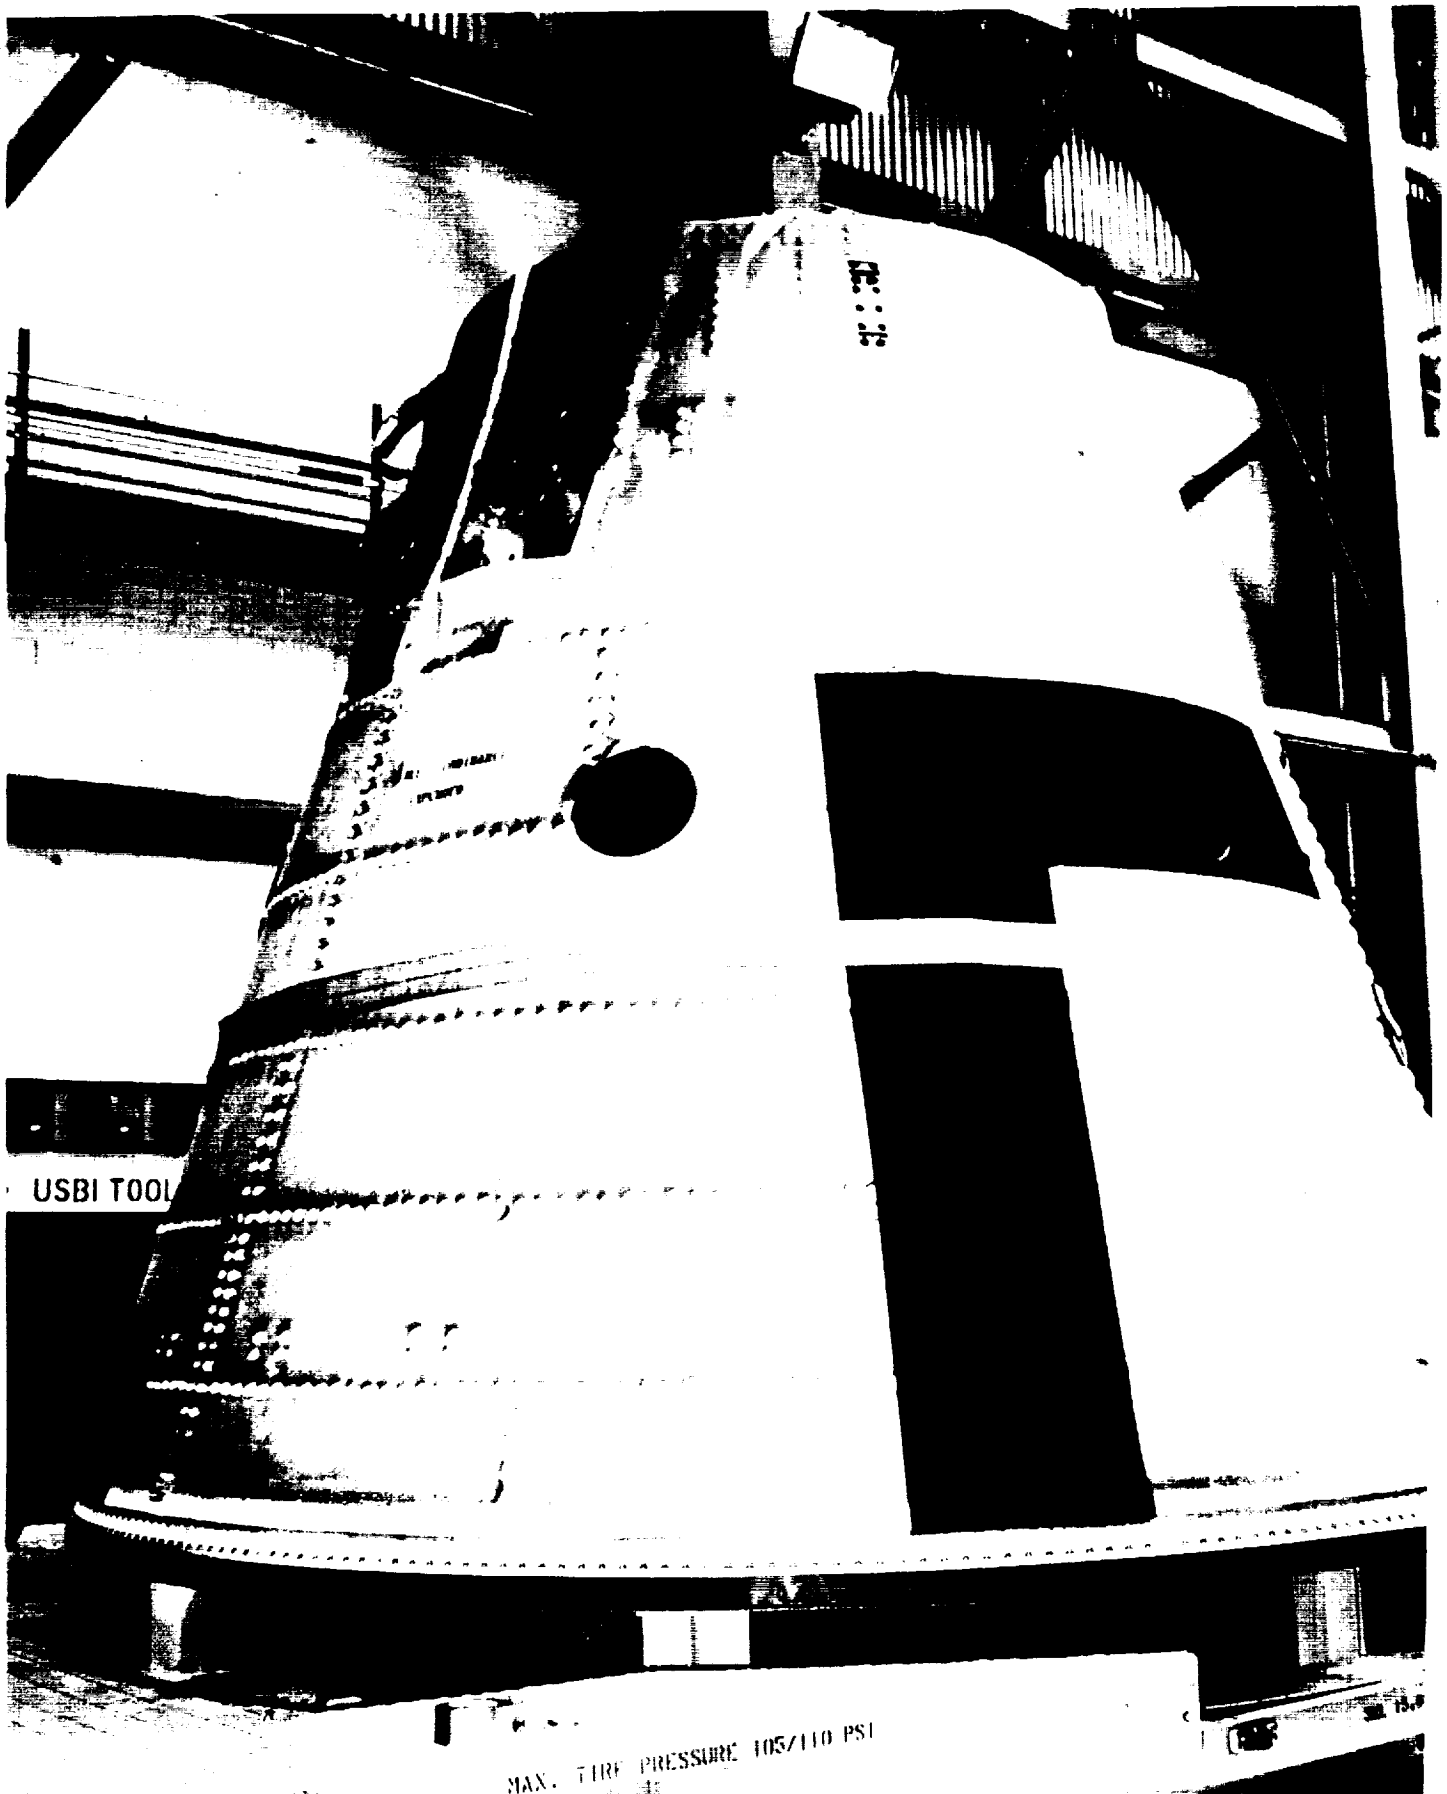
The LH frustum was missing no TPS but had 38 MSA-2 debonds over fasteners

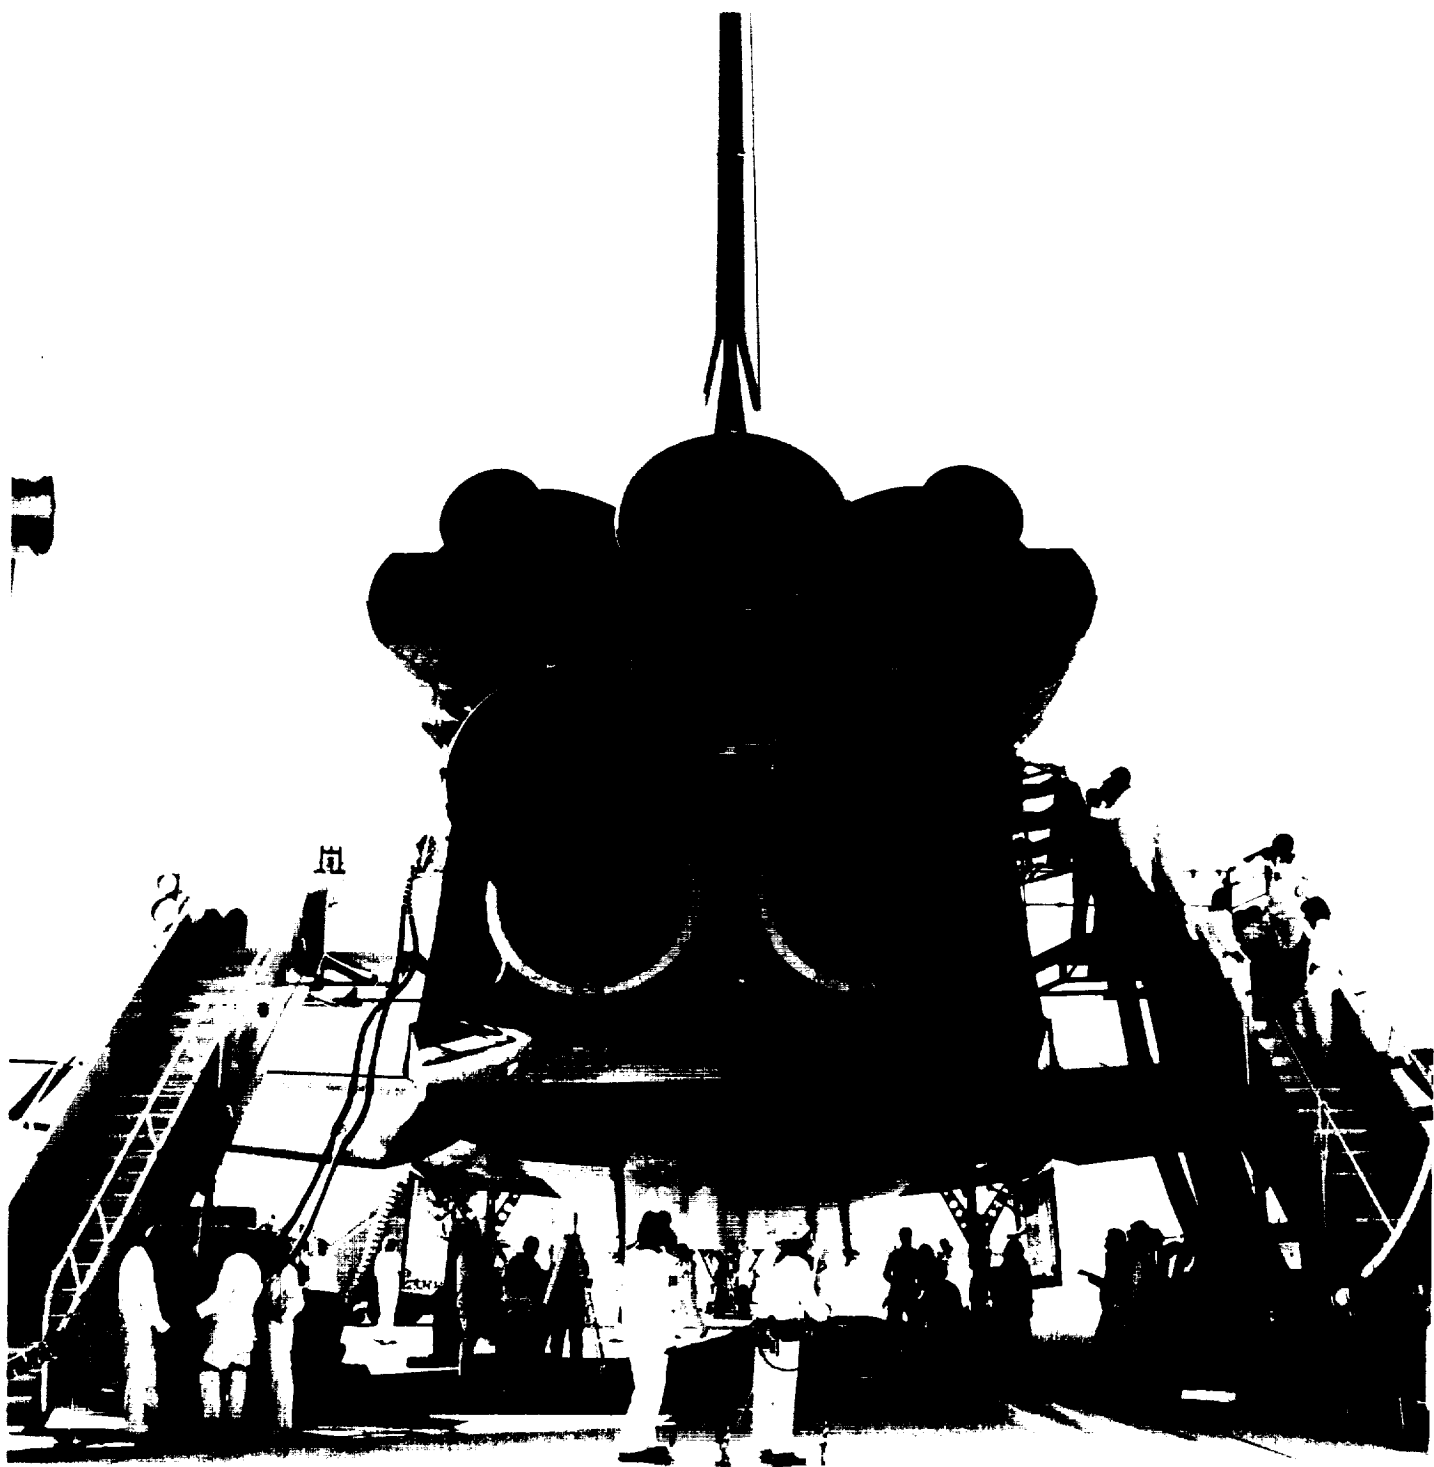
Overall view of SSME's and base heat shield. Note missing tile fragment from base heat shield inboard of SSME #3.
